THE WCR PRESS

Issue No. 10 - Thursday, December 31, 2020

TENTH EDITION

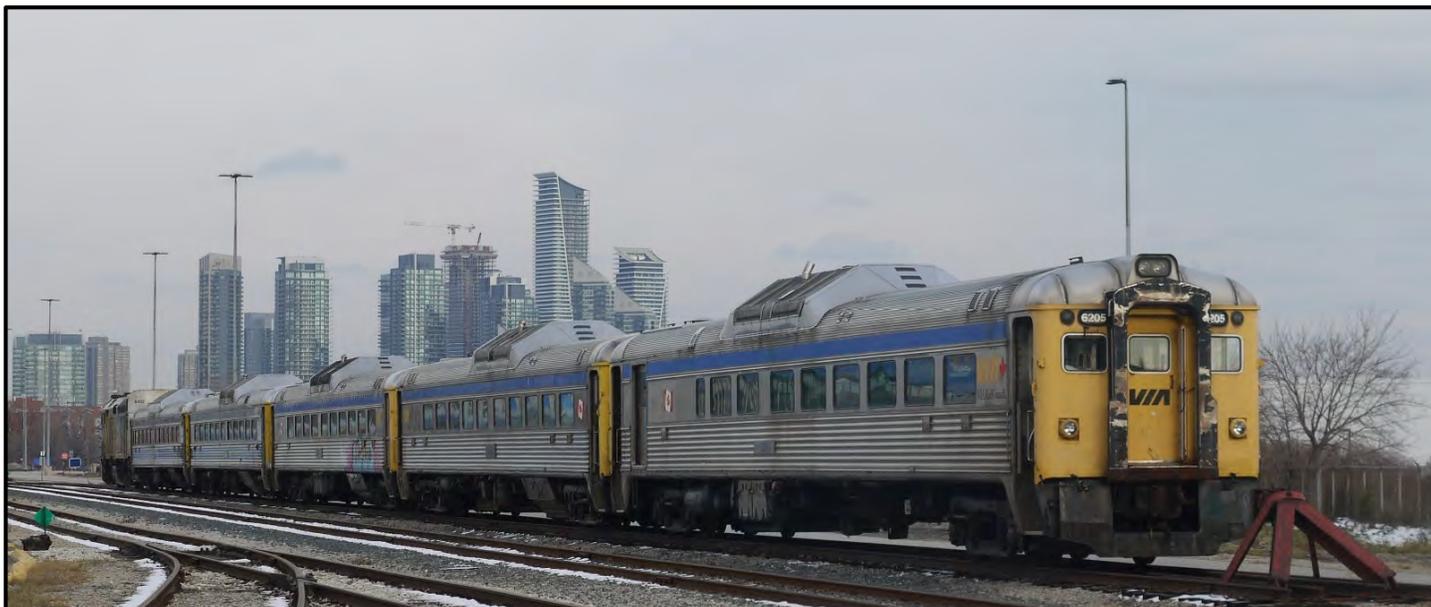
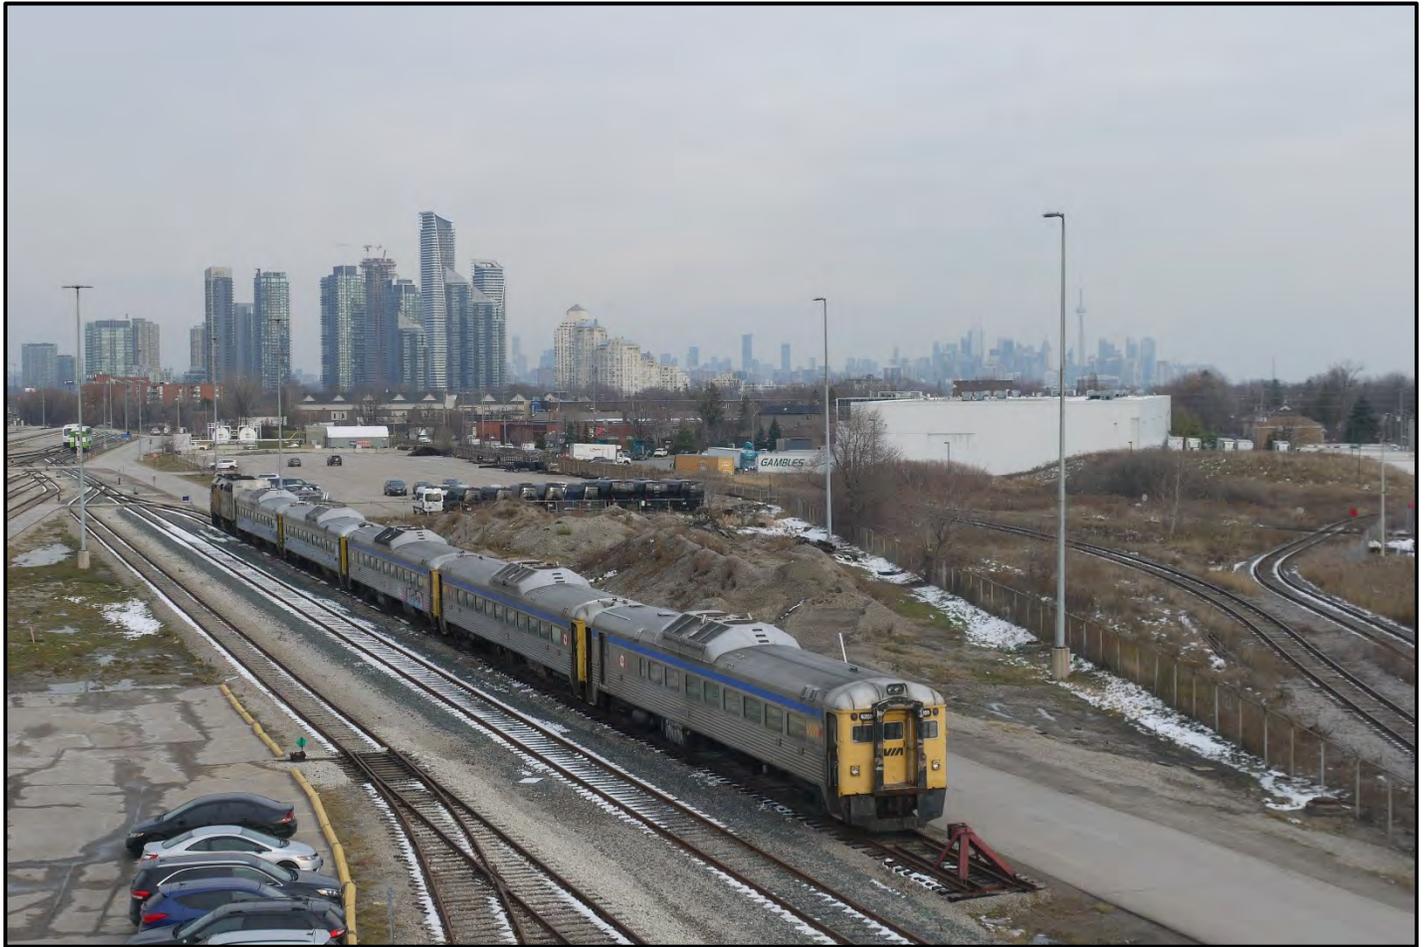
The WCR's "new" RDC's in these 2 photos are framed by the Toronto skyline as we work on them at TMC. A VIA locomotive is at the far end of the photo to provide train air to test the brake equipment as the repairs progress

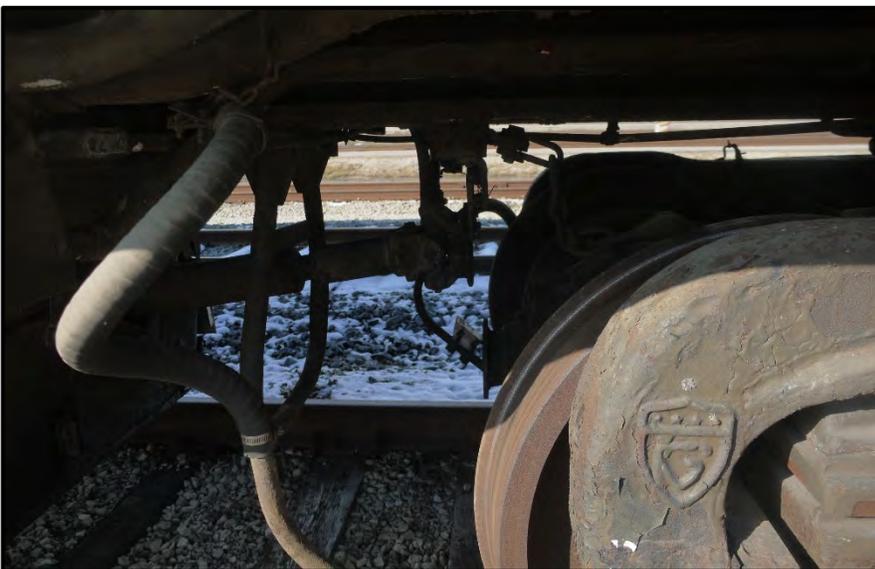
To move these units CN required that the drive shaft be disconnected from the transmission-torque converter on each axle. Norm, Greg & Matthew are shown here disconnecting the driveshaft on 6111 and slinging it in the bracket designed for this use.

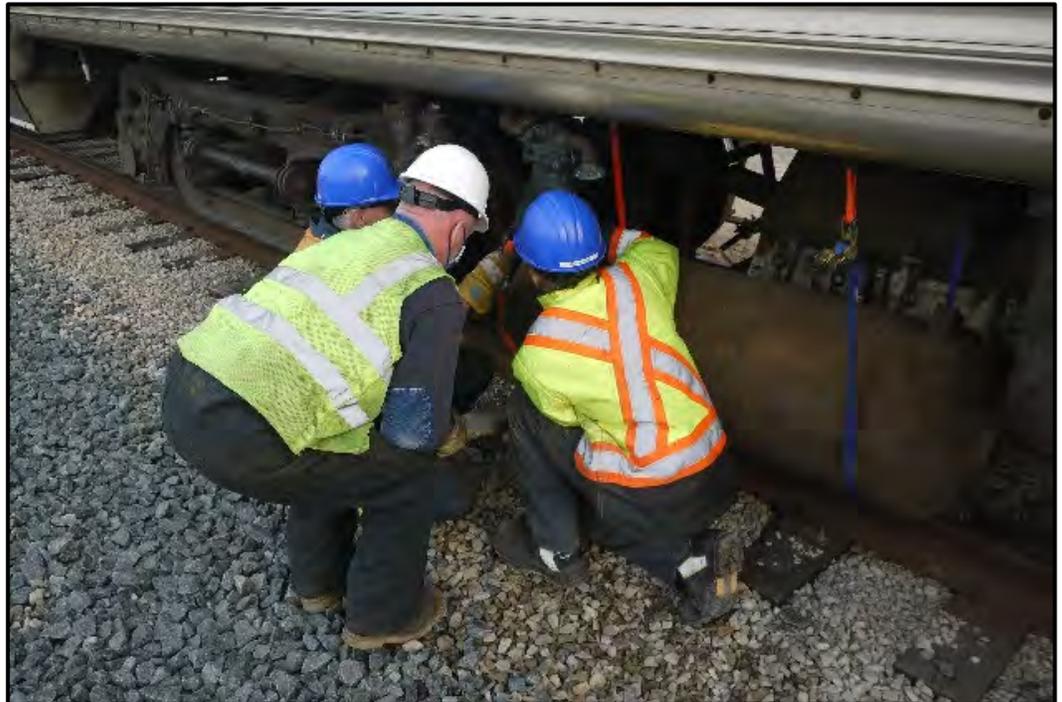
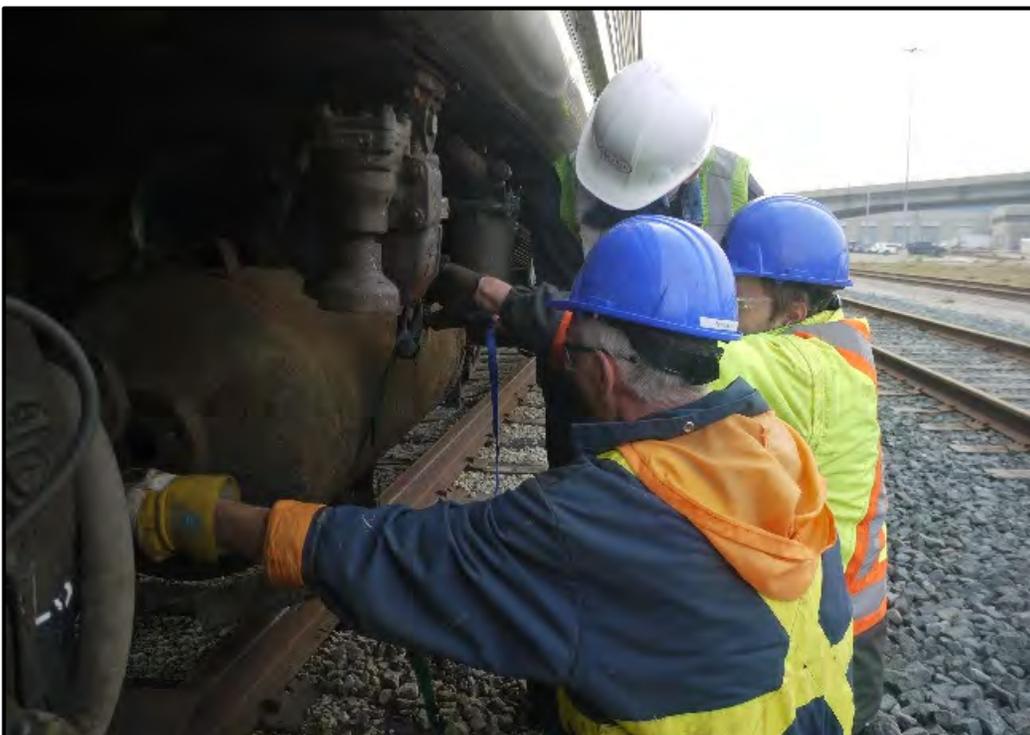
Norm, Greg and Matthew are shown here hoisting the "new" reservoir in the field into place using a series of straps and come-along.

Norm, Matthew and Greg have hoisted the tank into place and are working on lining it up with the car's air line on both ends of the tank and secure it to 6111.

This was quite an endeavour given this tank weighed several hundred pounds.

With the main air reservoir missing from 6111, Rapido loaned us one from their units.

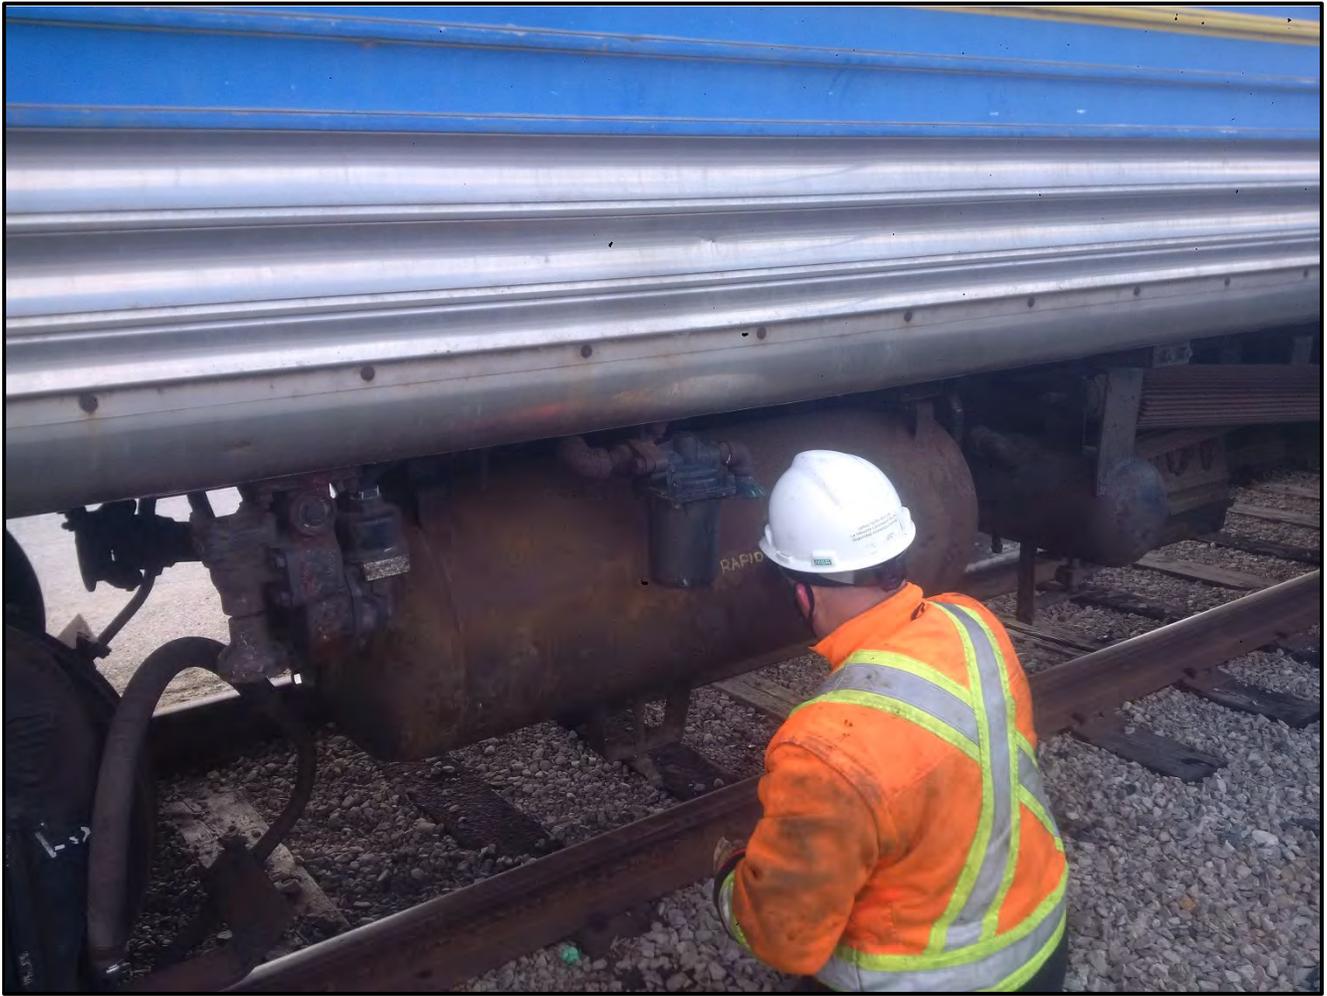
Chris Fox is shown doing the final inspection of the newly secured main reservoir on 6111.

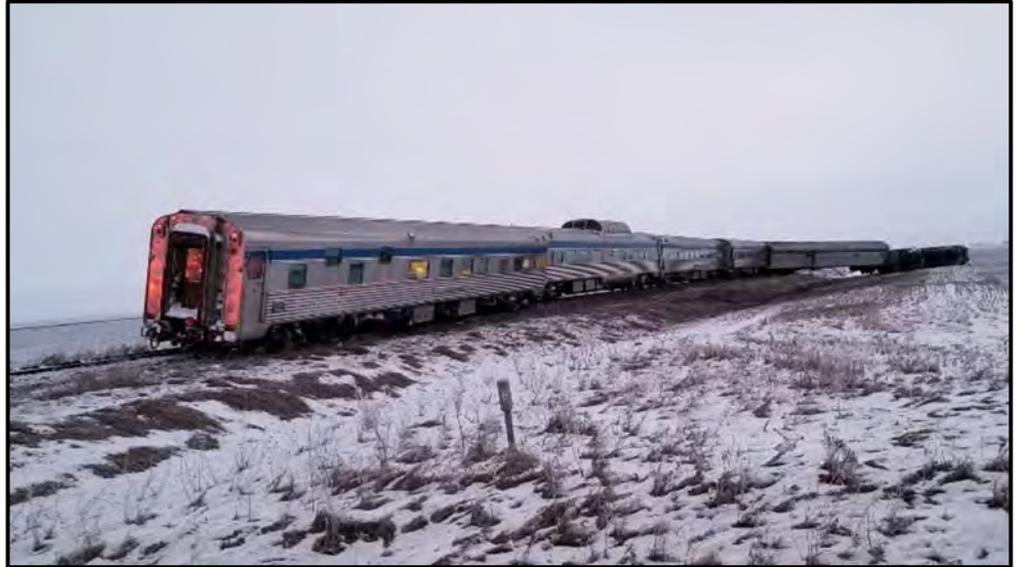
Via Rail derailement near Winnipeg on Dec. 31, 2019 caused by track defects (image courtesy of CBC.ca).

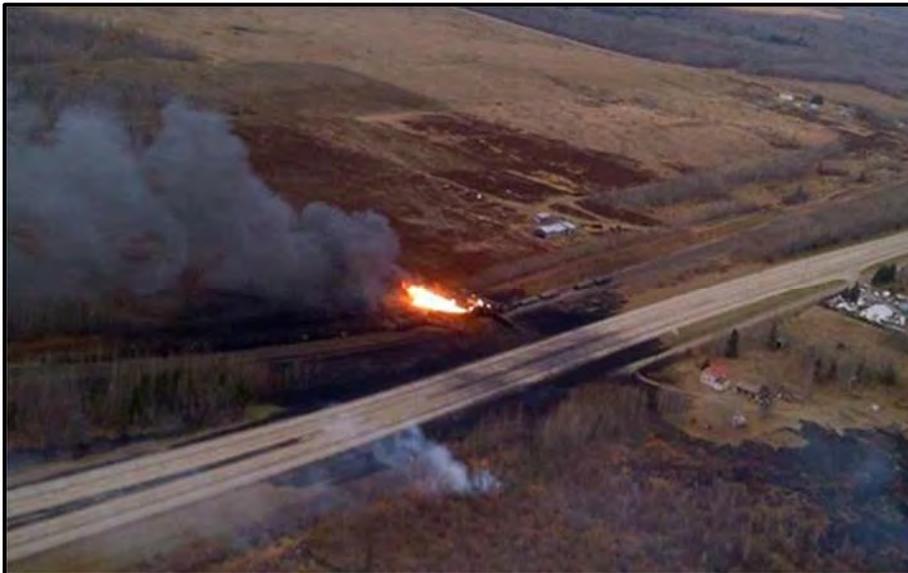
CN tanker train derailement in Gainford, AB, on Oct. 19, 2013 caused by rail defects (image courtesy of the Edmonton Journal).

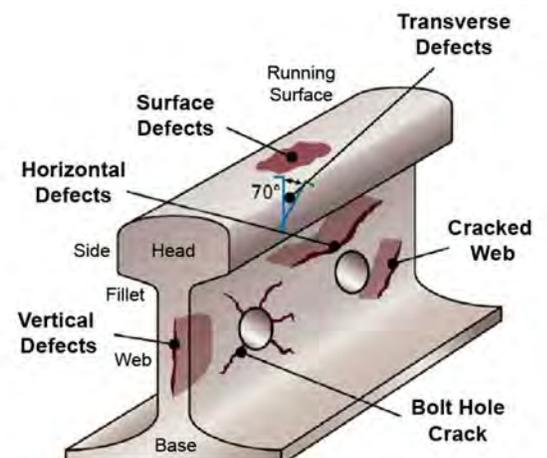
Some of the more common defects to watch for are labeled in this image.

Rail defects include many types of surface flaws, such as worn rails, corrugations, and rolling contact fatigue (RCF) initiated problems, such as surface cracks, head checks, squats, spalling and shelling, as well as various internal defects. Also, internal weld defects can lead to stress concentrations and eventual cracking.

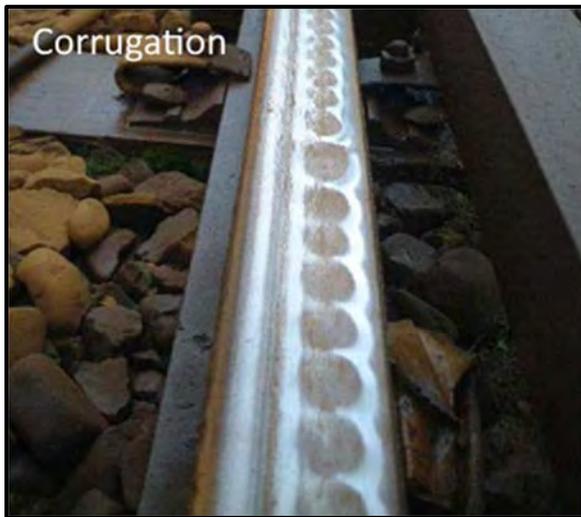
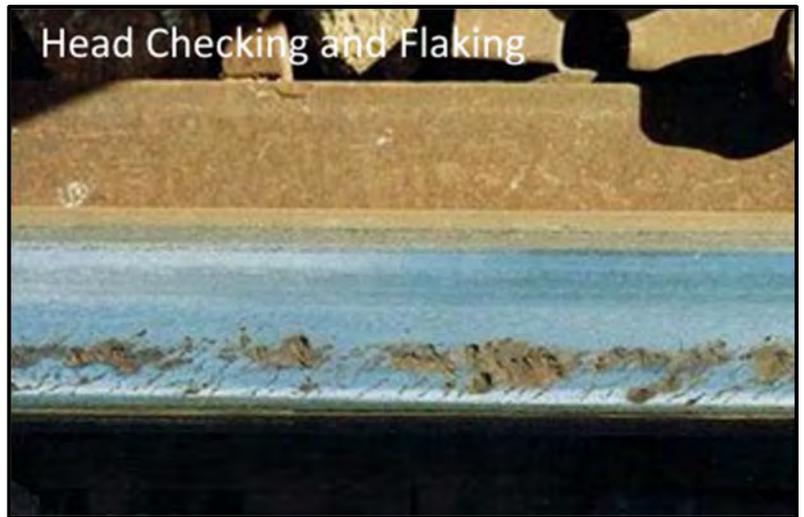
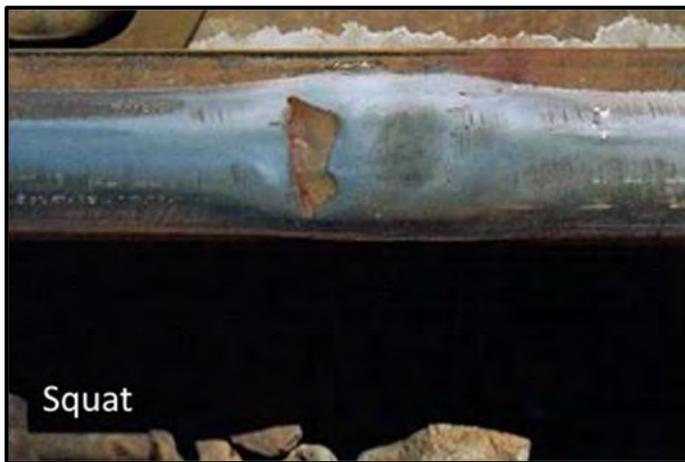
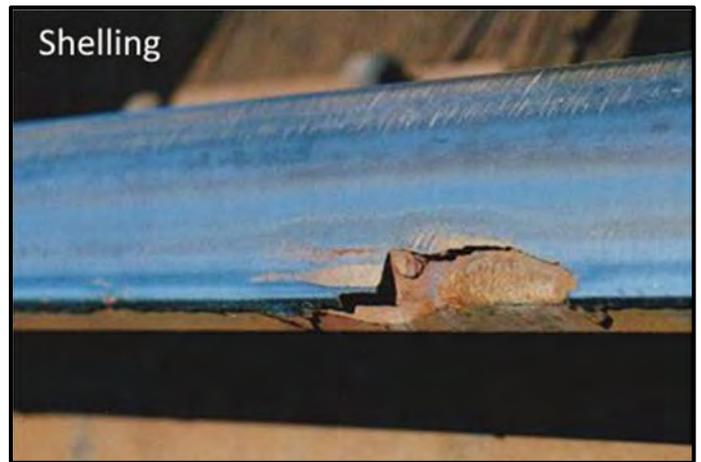
Transverse defects can be initiated internally below the rail surface with no visual evidence until the rail cracks, so it appears as if these types of fractures develop suddenly. They are particularly dangerous in curved track sections. In the image below, you can see how the crack grew internally until the rail could not take the loads, and suddenly split transversely.

Longitudinal defects also occur below the surface of the rail and can reach lengths of several feet. These defects can split the rail head into two parts, resulting in a large section of broken rail.

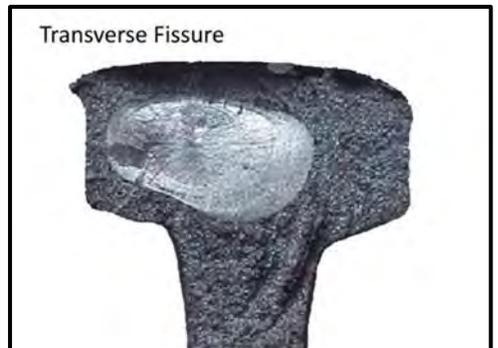
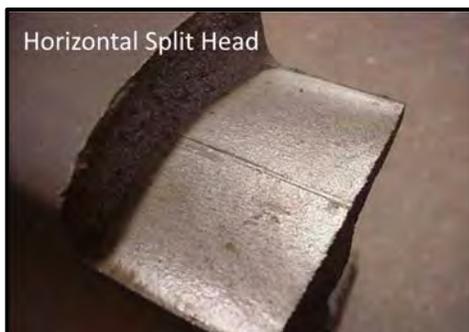
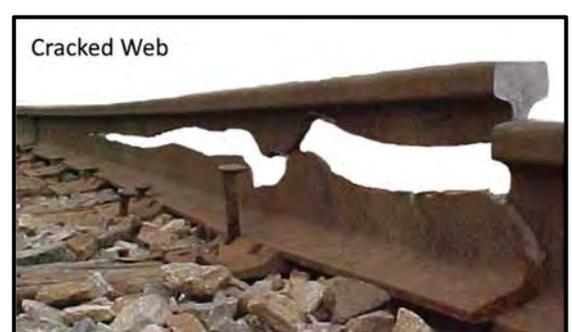
These two photos below show extreme cases, but even a much smaller case carries high risk levels because the consequences can be so large.

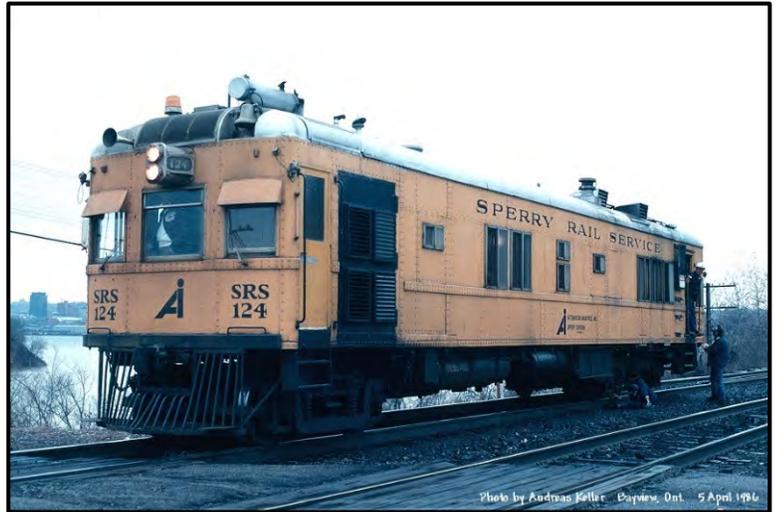
Sperry Rail Inspection Car. Photo by Andreas Keller, Bayview, ON, Apr. 5, 1986, courtesy of <http://www.northeast.railfan.net>

While significant surface flaws can be identified visually, smaller surface breaking cracks and critically important internal defects are more challenging. One of the first methods to locate internal defects was developed by Dr. Elmer Sperry in the 1920's, who built a rail inspection car that used large magnets to induce a strong magnetic field through the rail and coils for detecting the flux leakage for potential defects. Since then, Sperry Rail Service has grown into a leading company in rail flaw detection, with their familiar yellow flaw detection vehicles or "Sperry cars".

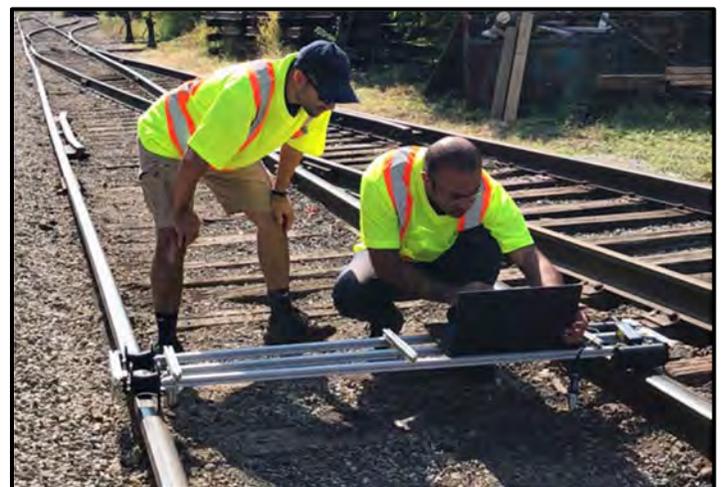
Field testing our prototype flaw detection device in St. Jacobs

We have been conducting field testing of our prototype device at the St. Jacobs train yard, with encouraging results. In addition to the hardware development, a key part of the work is the advanced signal analysis software that is required to analyze the complex magnetic field data from the sensors at speed. The next generation version of the field testing platform is ready, and will be undergoing testing on the WCR tracks in early 2021.

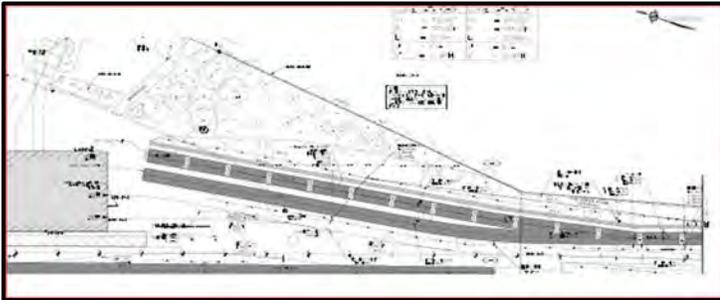
Track plans showing two new shop tracks and new turnout from shop tracks.

It was designed and shepherded over several years by John Vieth and Dave Banks through several different phases from GM Blueplan who did the drawings and the Region of Waterloo to obtain the required approvals. It entails the installation of new turnout (switch) on the Waterloo Spur "main" track south of the shop leading to new shop tracks. Extensive grading and site preparation for the new tracks and additional turnout required to split those 2 tracks is also needed.

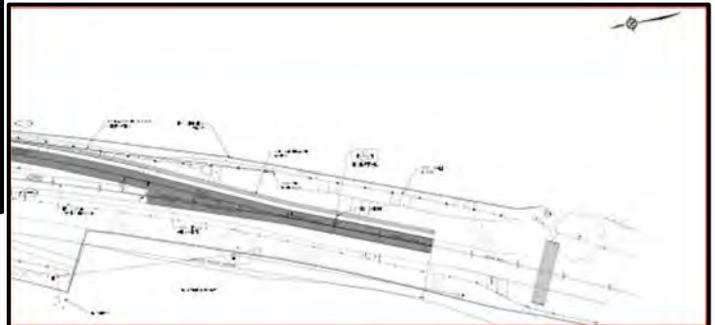
Track plans showing new turnout leading from "main" track to new shop tracks.

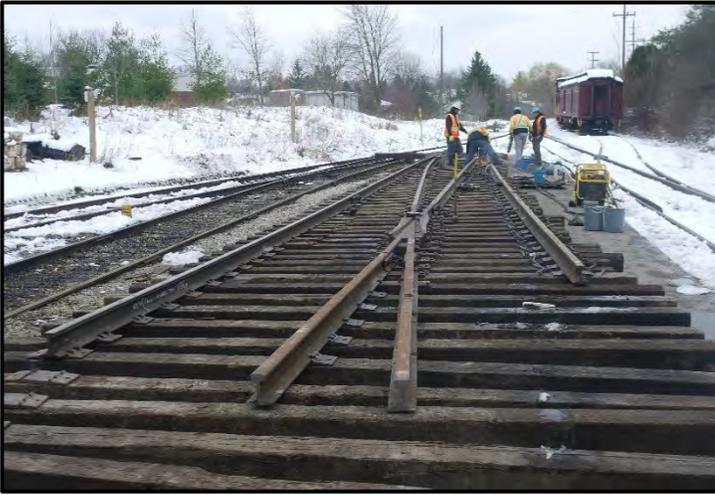
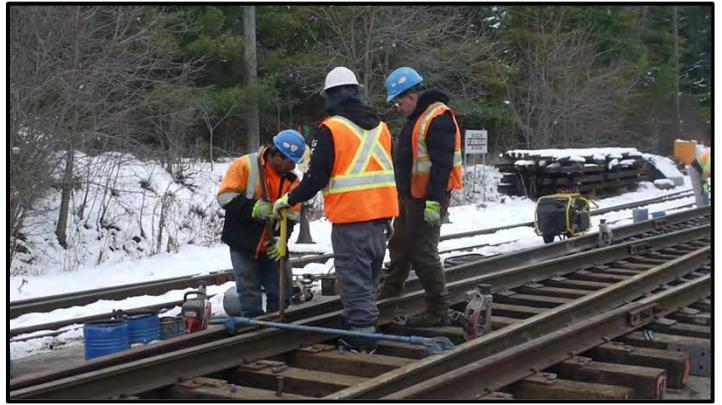
PNR crews lay out and construct the switch while the excavations take place to insert it into the "main" track.

PNR Railworks arrived in mid-November to start construction of the first phase which was the new No. 10 right hand turnout (switch). They constructed the turnout using a relay switch we had in stock, on the platform away from the area where it was to be inserted into the main track. When the turnout was completed, they cut out a piece of the "main" track where it was to go, dragging the newly completed turnout to the desired location and inserting it. This method does not compromise the main track and allows it to remain open except for one day instead of 3 or more days if built in place.

These photos show that process of the turnout construction from beginning to end. This switch lived to serve us another day and was originally from our Uptown Waterloo Station run around track and donated to us by the Region of Waterloo when that track was removed for the ION system.

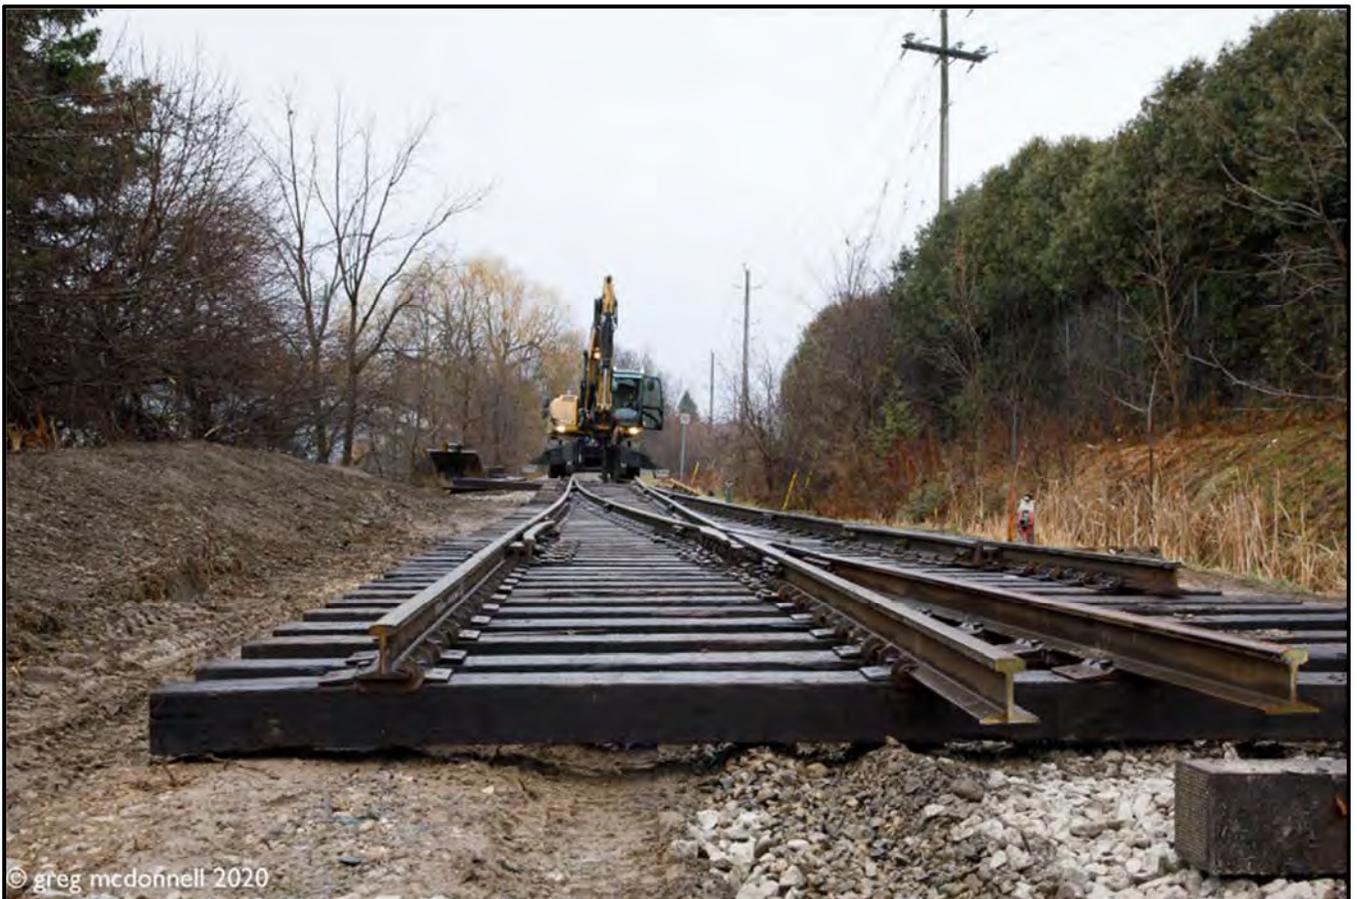
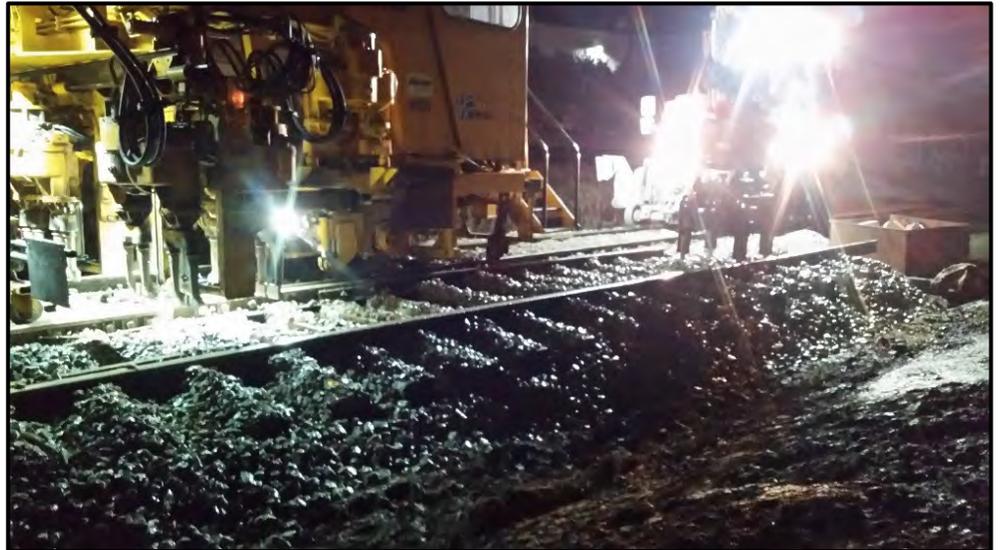
PNR crews move the completed turnout to the Waterloo Spur dragging it down the track to its new location, inserting it into the Waterloo Spur "main" track. The two photos immediately above show the new turnout in place facing south towards Waterloo and north to the shop.

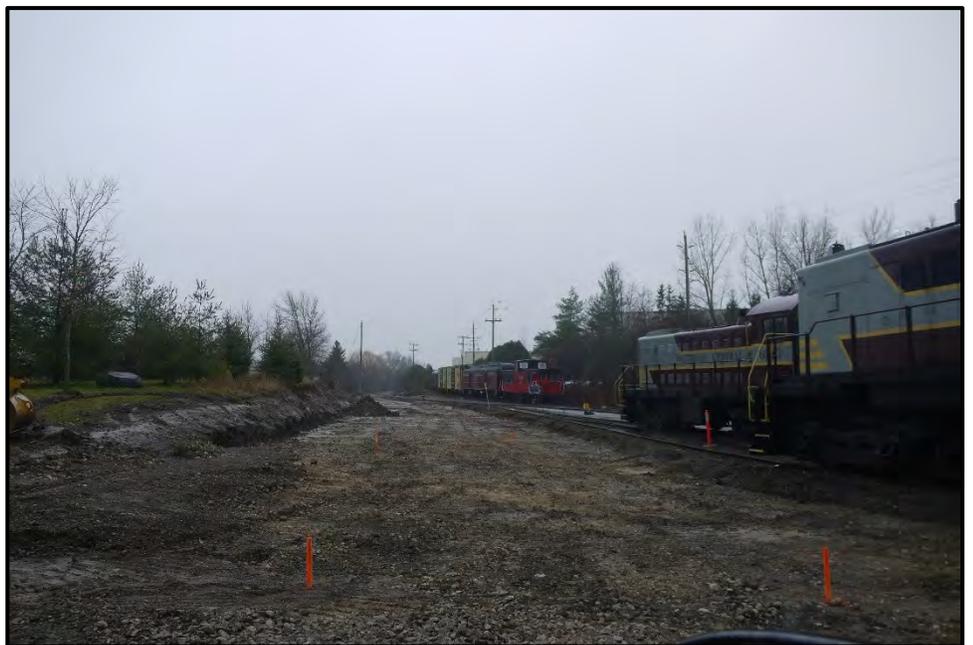
With the ballast spread out in a depth of 4 to 6 inches, the area is now ready for our volunteers to commence laying the ties we have on site. We also received a donation of 60 concrete ties that will be used in this area. Concrete ties come with the tie plates installed and we plan on using these at a predetermined space with the wood ties to assist with providing the correct gauge as we move along.

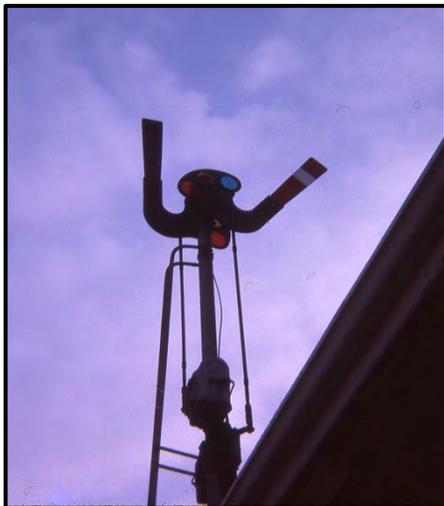
Three indication train order signal.

Stations were outfitted with train order signals, often semaphore-style signals, that informed approaching trains of orders to be delivered at that station. In later years train orders were of two types: "19R" and "19Y" Upon receiving 19R train orders, the station operator was required to place the train order signal in the red, or "stop" position. Trains were required to stop to receive 19R orders, some of which needed to be signed for by a member of the train crew, particularly if the restriction in a specific order took effect at the issuing station. A yellow indication on the train order signal informed crews of "19Y" orders that could be delivered to a passing train at speed. A green indication on the train order signal meant that no orders were on hand for delivery to the train.

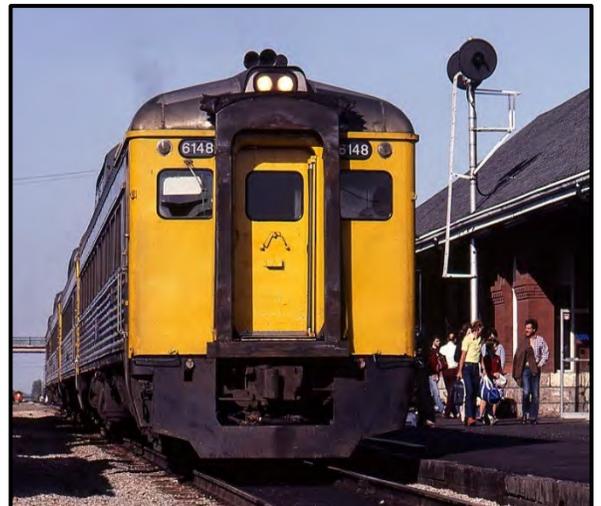
At the end of the train order era the semaphore signal is replace with a modern signal showing all 3 colours

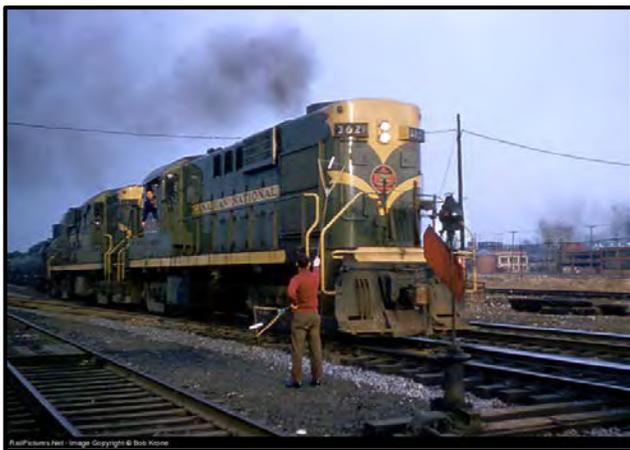
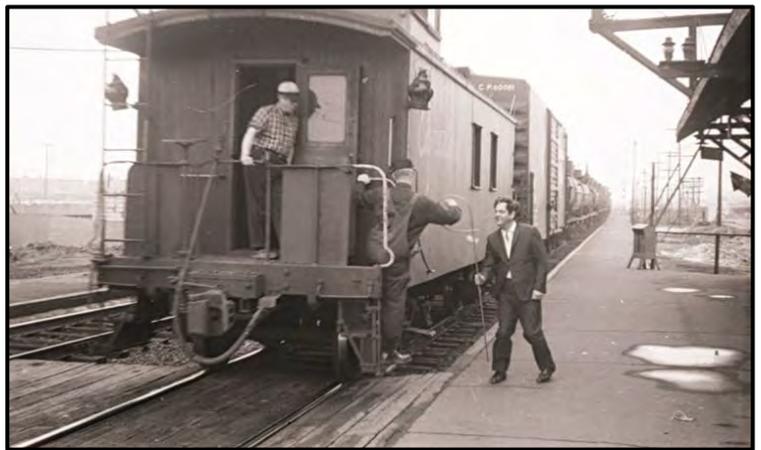
Handing up orders was part and parcel of the operator's job. For many years, a bamboo hoop with a metal clip holding the orders was used. Its big drawback was that it had to be returned by the crew, who simply threw it along the right of way. Pity the hapless operator who had to trudge down the track to retrieve the hoop in winter or during an electrical storm. In later years, operators used a fork holding a string in which a slip knot was tied to hold the orders. The crew member simply slipped his arm through the fork, the string slipped out of the spring-loaded latch that retained it, and the orders were in hand. On many roads, permanent order-hoop stands, or racks allowed the operator to "load them" and then stand back and inspect the passing train. Regardless of the improvements, delivering orders was not pleasant under any circumstances. Operators had to watch for shifted loads and flying brake shoes.
